MEMORANDUM State of Alaska

SUBJECT: Solid Waste Permit
 Number 0111-BA001
 Kennecott Greens Creek
 Mining Company
 November 4, 2002 Inspection
 of Potential ARD Sites
 Not Covered By Permit

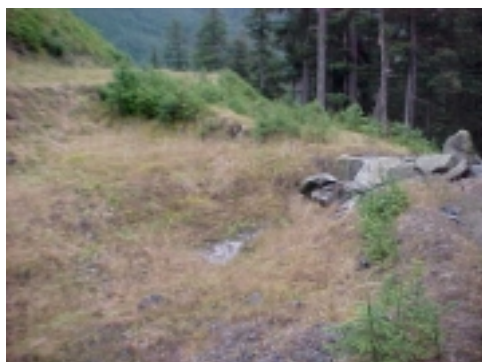
Old, breached Sediment Pond at Site 1350

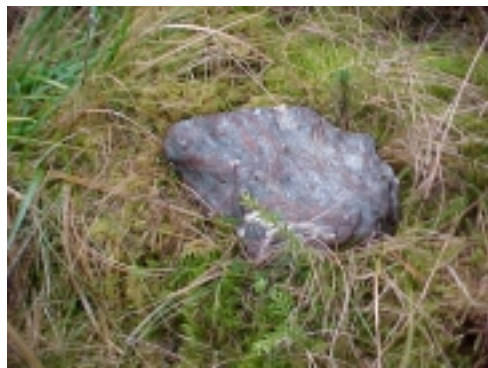
Oxidized pyrite in rock at Site 1350

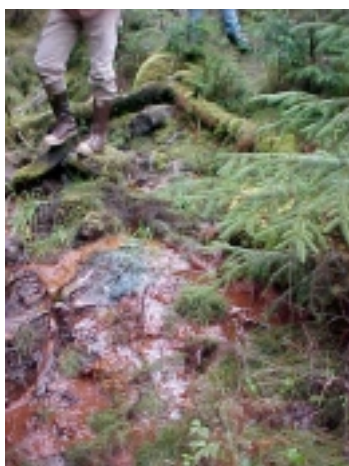
The southeastern aspect of the site had a small (approximately 10 gpm) seep with a rusty orange colored precipitate. The likely source of the seep was an observed small natural stream located approximately 100 feet upgradient of the seep where water appeared to flow along the toe of the fill from an upslope, natural area. The seep area appeared to be fed by exfiltration contact waters from within the pile. An old sedimentation pond was located on the fill nearby and the retaining wall had been removed. There is now no ponded water at this location. However, the flat surface may provide an opportunity for run-on. Monitoring of the seep under the stormwater monitoring program (2 samples) shows a neutral pH with a possibly slightly elevated zinc (see

Southeastern seep water

It appears that diversion of run-on water at the southeastern edge may help to minimize or prevent the seepage condition. It was noted this water source was designated in the FWMP as the "mine adit discharge" even though it does not emanate from, or even flow past the adit. At one time there was a mine drainage component, but this no longer exists. The water from this site is now a natural surface source of water augmented by exfiltration waters seeping from the toe of the pile. KGCMC refers to it in their spring, summer and fall FWMP monitoring as the "east adit discharge".

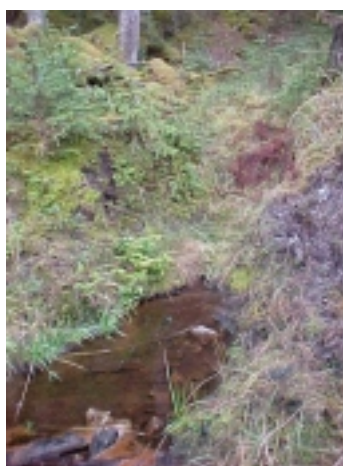
Run-on "east adit" water

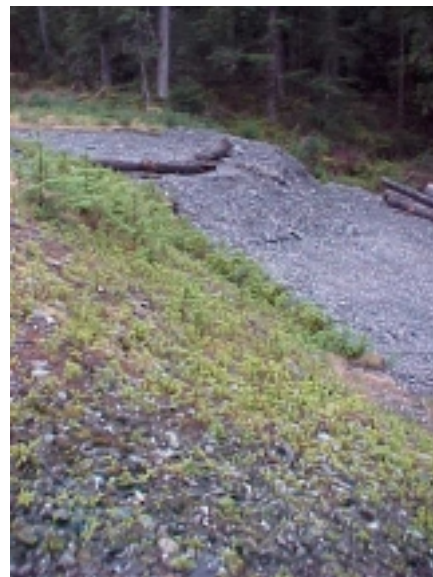
Site 960 Slope

On inspection an orange colored precipitate was observed in the drainage at the lower aspect of the fill. The flow was approximately 3 gpm however, this may increase after precipitation events.

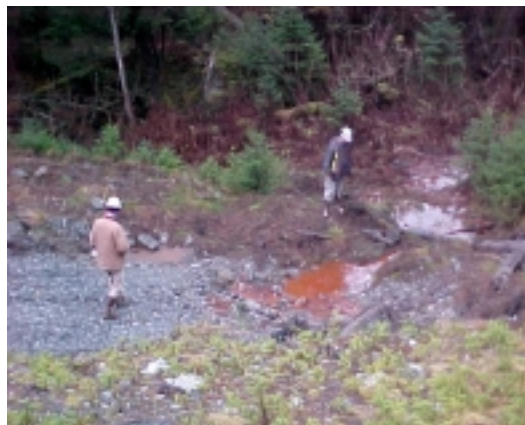
The seep flow infiltrates into the muskeg within a short distance. According to Shepherd-Miller 2000 study this seep had a zinc concentration 9.75 mg/l (dissolved) and pH of 6.4. Storm water monitoring conducted at the site indicate a pH of 6.8 and a zinc concentration of 4.7 mg/l. Storm water sample results remain fairly consistent over time, see Attachment “B” to this report for the sample results. There is a FWMP monitoring station located 1750 feet downstream on Greens Creek. Zinc concentrations at that station over the last 5 years remain well within water quality limits.

Downgradient Drainage Water at Site 960

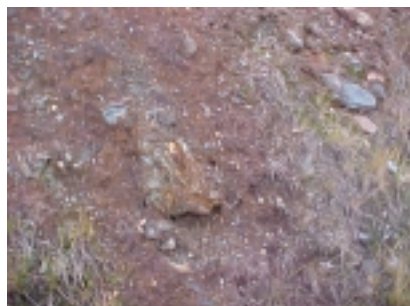
Oxidation of Exposed Pyritic Rock

In some areas where revegetation was unsuccessful there was an observed rust colored precipitate/staining that indicated an oxidation process occurring in the underlying substrate and possibly localized acidic conditions. It was reported by KGCMC that lime and polymer has been applied to the surface of the area on several occasions to neutralize any acid generation.

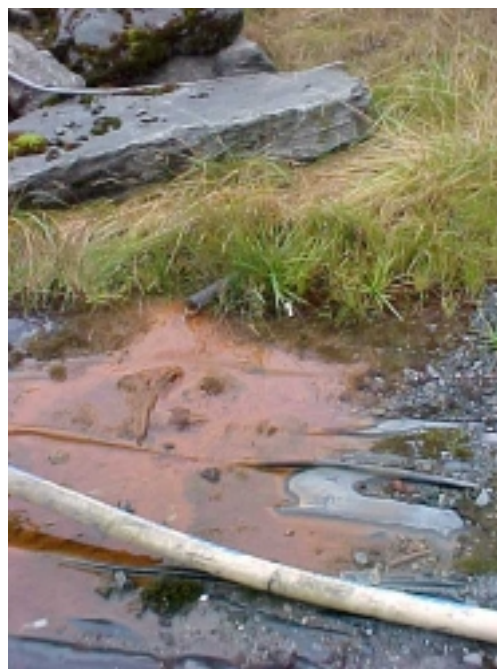
A small flow of water was observed from two of the drains. The drainage outflow had a rusty orange colored precipitate. Internal monitoring conducted at this site in 1995 and 1996 revealed neutral pH. Metals results indicated no exceedance of water quality standards. It was reported by KGCMC that precipitation events will flush acidic run-off from portions of the surface into the lined ditch which collects run-off. Both surface run-off and underdrain flows are collected and treated under a NPDES permit.

Underdrain at Site 920 Millsite flowing into lined containment ditch

The waste rock in this area will ultimately be excavated and placed underground at the end of the mine life. In the interim, all runoff waters are captured and treated, while KGCMC management continues addressing the materials, while monitoring documents the status of the area. The bonded cost estimates for this site is \$362,548 for backfill, recontouring and revegetation.

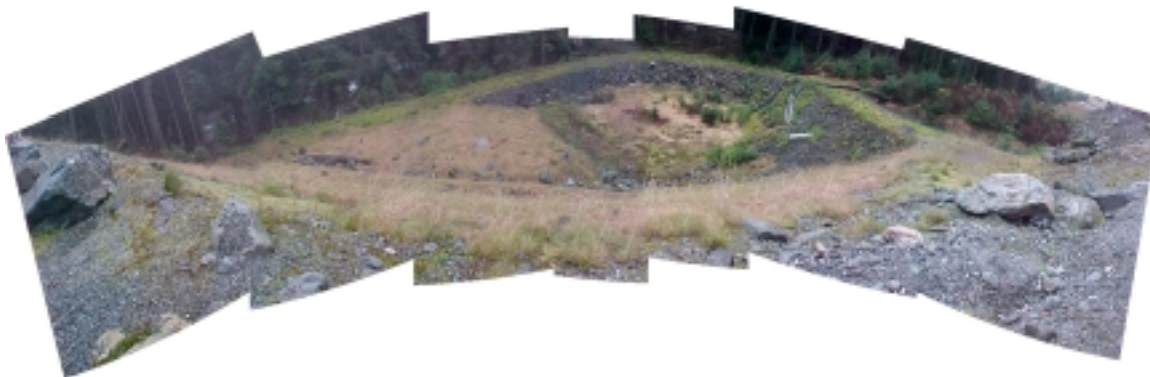
Site “C” Panorama of Downgradient Aspect – Note Proximity of Greens Creek

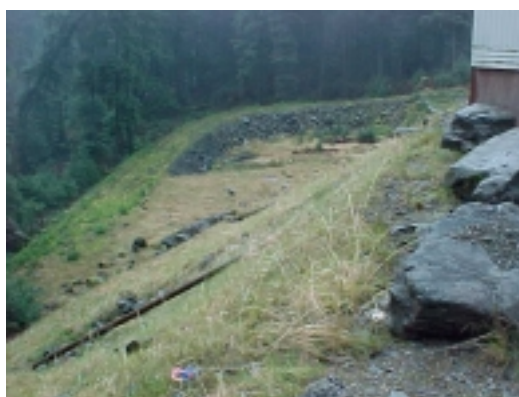
Sediment Pond Site “C”

According to the reclamation plan this area may be excavated and backfilled into the mine at the end of the mine life. The site is also bonded and being considered for the application of a closure cover system using a similar engineered soil cover system to that installed and being tested at Site 23. This final cover system utilizes profile #4 from the Unsaturated Soils Engineering Ltd. (USE), December 1998 report. The Department has approved the use of this profile in the waste disposal permit for the tailings and Site 23/D and it is incorporated into the reclamation plan. The bonded cost estimates for Production Rock Site “C” is \$193,430

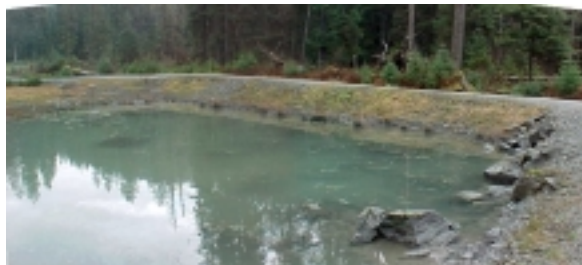
Site D Berm - Inside

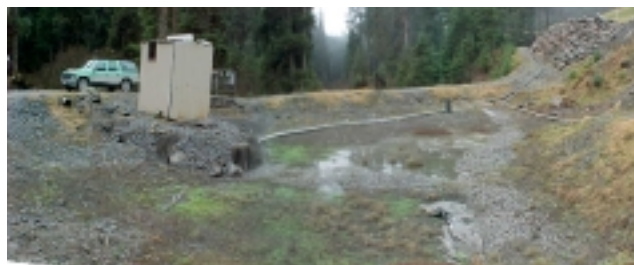
Site D Berm – Inside and pump house over wet well

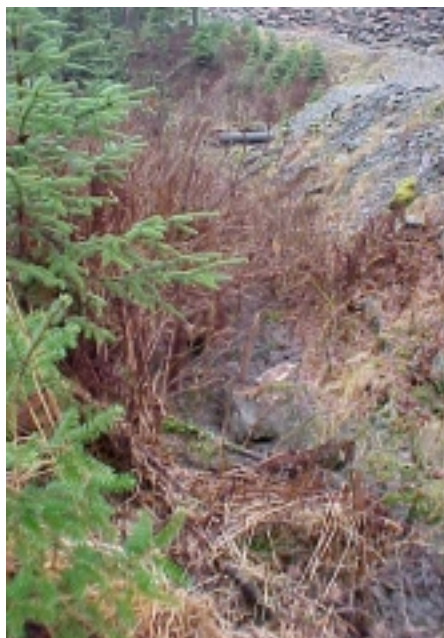
The berm at the lower aspect of Site D was constructed to contain the surface and groundwater runoff from Site 23/D and to provide sedimentation control. The berm was composed of pyritic quarry rock from the development Pit 405 in 1988. There have been reports of seeps through the berm when the pond contained behind the berm was full. However, at the time of this inspection there was no evidence of seeps as active pumping maintains the pond empty or very low other than during major storm events. There was no evidence of iron staining or stress to vegetation outside of the berm. Keeping the pond level down prevents leaching through the dike. Any seepage that passes through the dike would flow into the adjacent Greens Creek wetlands. Greens Creek is located within 100 feet of the berm.

Site D Berm – Outside Aspect

At the end of the mine life the berm will be excavated and placed at Site 23 or underground following installation of the final engineered cover system over Site D. In its place there may be an infiltration gallery or a natural attenuation system. The reclamation bond amount for all of Site D is \$831,562. This includes costs for earthwork, the final cover system, revegetation, engineering, instrumentation and monitoring.

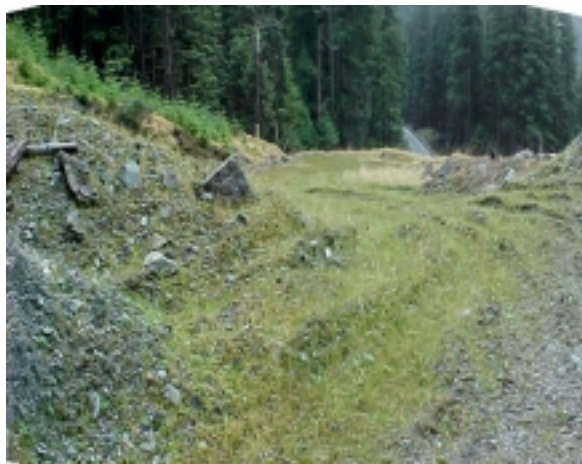
Pit 405 – Looking downhill

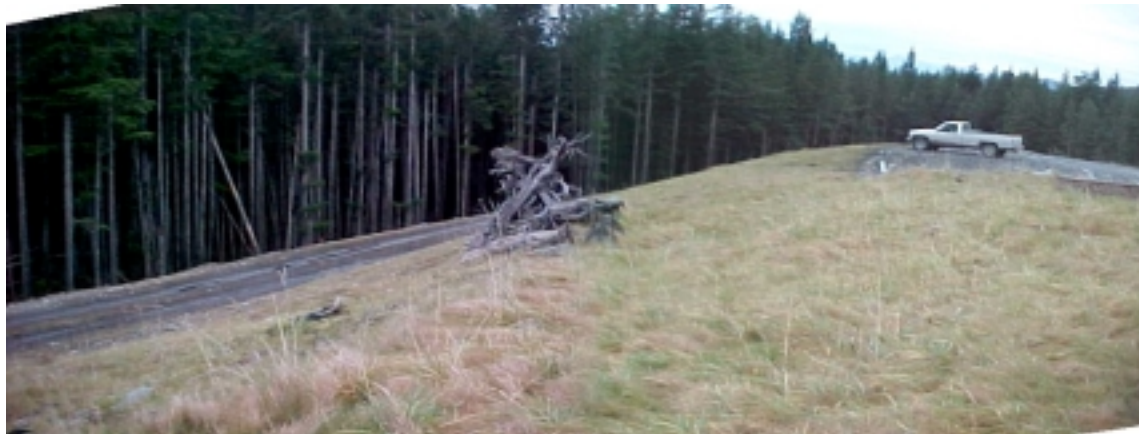
Waste Site E Southwestern Aspect

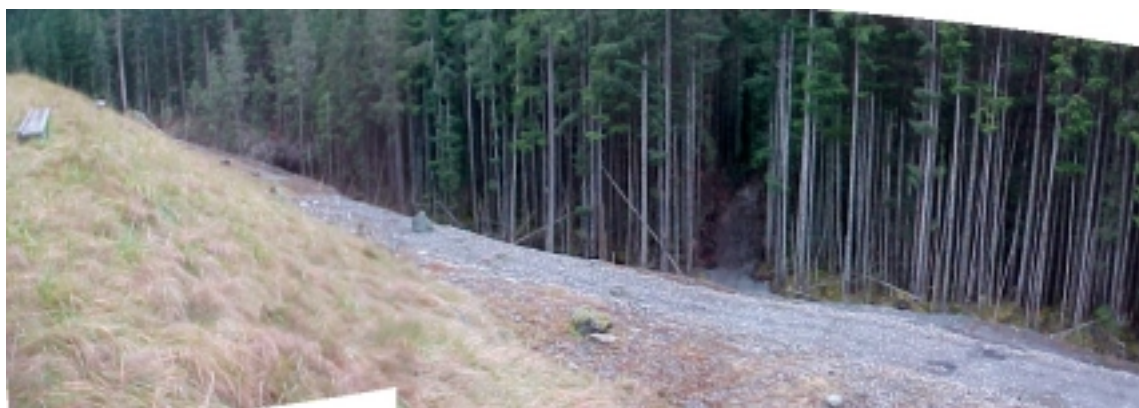
Waste Site E Southeastern Aspect: Looking into the access clearing for Well DH-02-09

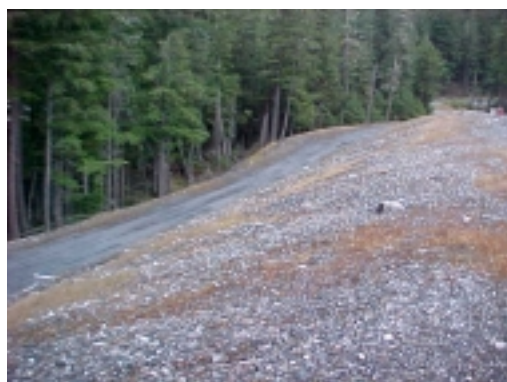
Waste Site E – Northeastern Aspect

waters down-slope from the site. A spring was observed some 70-80 feet downslope from the waste pile, near well DH-02-03. Apparently at springtime there is a band of wetter soil at this elevation and location that supports ferns and other vegetation more lush than that in the surrounding forest area. During periods of high rainfall, an incised gully near DH-02-09 drains runoff that collects at the base of the pile's southeast side, an area soon to be covered during re-contouring and cap placement.

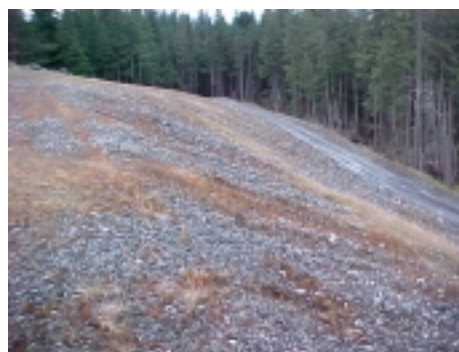
Waste Site E – Northwestern Aspect

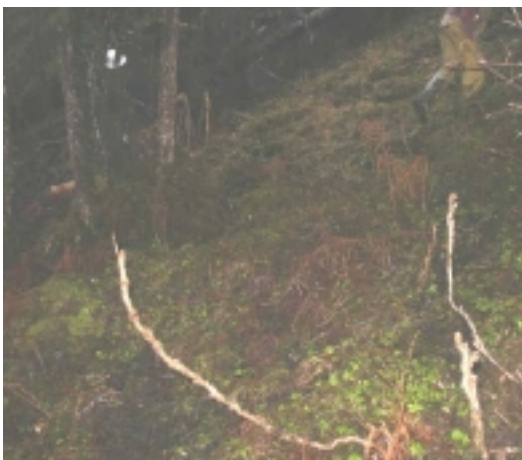
Wet area near well DH-02-03 where fern growth indicated a band of increased groundwater flow

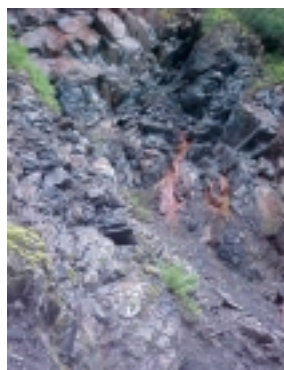
There was an observed iron stained rock material at the periphery of the site. Additionally, there were areas in the cliff at the entrance to the site that had an observable orange rust stain. This did not appear to be hydrologically connected to the material that was placed in the pit.

Pyritic Iron Staining

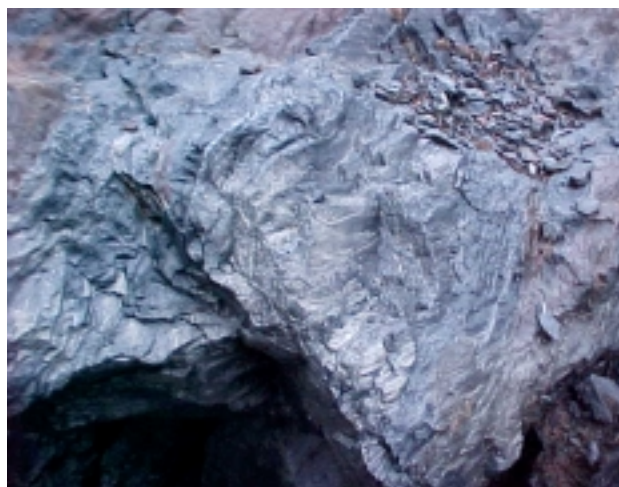
The Zinc Creek bridge abutment is located at milepost 3.0 on the B-Road at Zinc Creek. The abutment supports the bridge at its northernmost aspect. It contains pyritic rock that was reported to be blasted from rock outcrops during the development of the B-Road in the vicinity of milepost 2.5 (discussed in the next section). The variable presence of pyritic rock was observed on inspection.

Pyritic Rock at Abutment

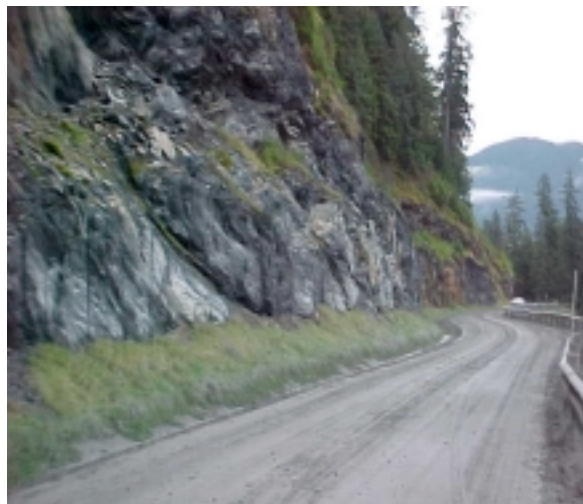
Blasted Rock Along Mi 2.5 B-Road

The bedrock cliff in the area of 2.4 to 2.6 mile was blasted in order to develop the B-road through this area. Evidence of pyritic rock and iron staining were observed on the uphill rock faces at several places along this stretch of road. This material was reported by KGCMC to be used in the bridge abutment at Zinc Creek and the pull-out at milepost 1.8 of the B-Road. The nearest sensitive environmental receptor from the mile 1.8 pull-out is located approximately 2,500 feet downgradient at Tributary Creek. The nearest sensitive environmental receptor from the mile 2.5 road-cut is located approximately 200 yards at Zinc Creek.

All roads will be reclaimed at closure of the mine. Pyritic material in this road section is planned to be excavated and deposited inside the tailings disposal site at closure. The bonded cost estimates for reclamation of this section of road is \$46,412. This includes funds for the removal of the potentially ARD forming pyritic rock from the road base.

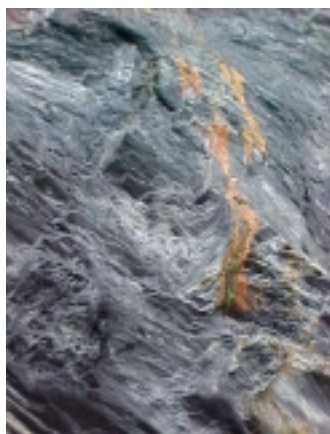
Pyritic Rock Iron Staining

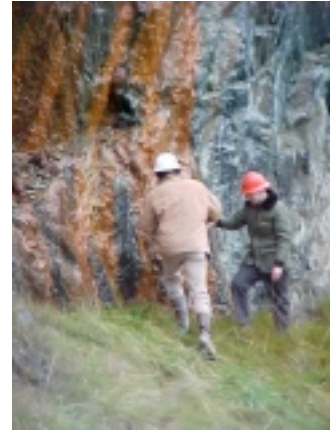
Pyritic Rock Iron Staining

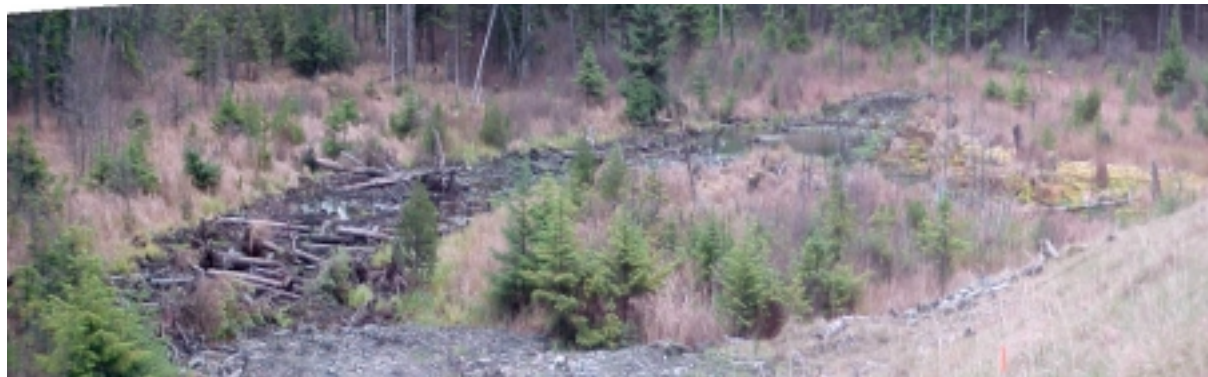
Old Road Downgradient of the South Main Embankment Slurry Wall – Photo Taken From Embankment

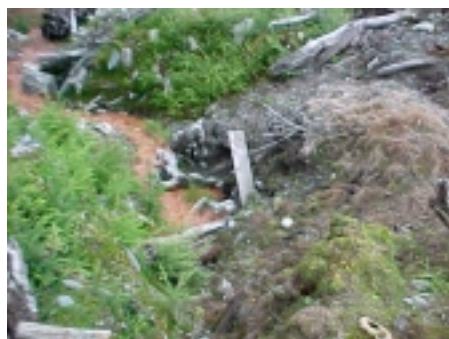
There was an observed orange colored precipitate/staining in the run-off water. This staining appears to have resulted from the material that is stored as it only appeared following placement of that material, rather than the result of the pyritic rock observed on the side-wall of the rock pit. The orange colored precipitate was likely due to a non-sulfidic iron redox reaction. This is less of a concern with regard to metals leaching.

Downgradient Run-off Water Pit 7
